Title: Microscopic Examination of the Corroded Hagan Container Used to Store
Molten Salt Extraction Residue XBPS333

Microscopic Examination of the Corroded Hagan Container Used to Store Molten Salt Extraction Residue XBPS333

Joshua Narlesky, Kennard Wilson and Elizabeth Kelly

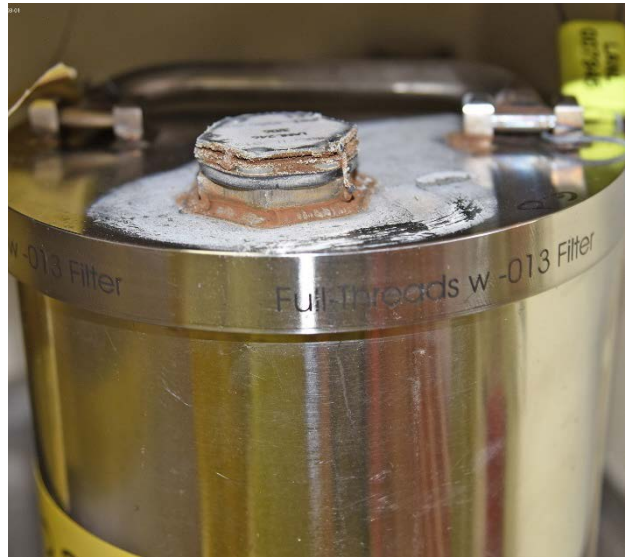
In 2016, a Hagan container was found to have a white powder and rust covering outside surface of the filter cover and part of the lid during an In-Service Inspection in the vault [1]. The item, XBPS333 had been in storage for 8.1 years and consisted of 978 g-net of material containing 80 g of plutonium and 23 g of americium. The material form is residue from the molten salt extraction (MSE) process and referred to as an MSE salt. These materials are known to contain hygroscopic chloride salt compounds including MgCl_2 , PuCl_3 , and possibly AmCl_3 . In vented containers, the stored materials have the potential to adsorb moisture from the atmosphere. Prolonged exposure to relative humidity above 30% (considered an off-normal event) could lead to hydration and deliquescence of the chloride salt compounds, increasing the likelihood for corrosion of the inner packaging in contact with the stored materials and gas-phase corrosion due to the generation of corrosive gas species.

Figure 1. Image showing the condition of the XBPS333 Hagan container in the vault [1].

Immediate concerns for radiological contamination and the identity of the white substance were resolved by taking radiological smears around the container and analytical samples of the white powder deposited on the surface of the container lid and on the window of the storage location. No contamination was found on the external surfaces of the container. The white deposits on the container were determined to be ammonium chloride, and the deposits on the vault window were found to be lead chloride. The ammonium chloride and lead chloride were presumed to be the products of reactions with hydrogen chloride gas, produced by radiolysis of the PVC bagout bag and possibly by radiolysis of hydrated chloride salts in the material matrix.

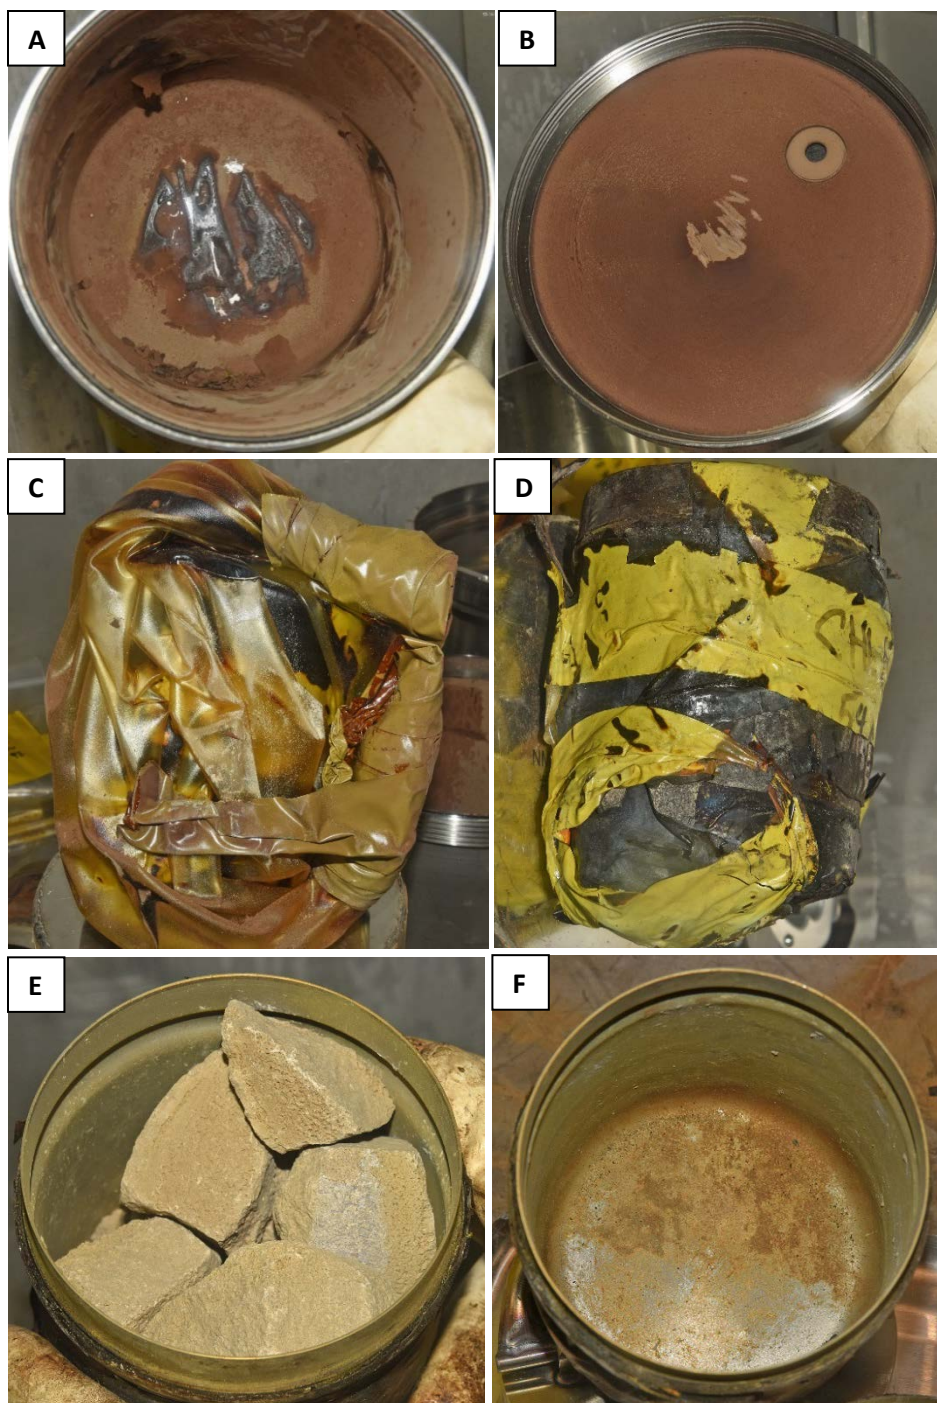
Due to concerns regarding the condition of the inner packaging and the likelihood that the inner surfaces of the Hagan container may have radioactive contamination, the container was introduced into the glovebox line for opening and repackaging. The container was opened, and images were taken to document the configuration and condition of the inner packaging. The images, which are displayed in Figure 1, show that inner package consisted of a taped slip lid container inside two bagout bags. The material was in the form of large chunks with a small amount of finer grained material on the bottom. The innermost bagout bag was completely black, brittle, and adhered to the container. The outer bagout bag was yellow to black colored and severely degraded. The inner surfaces of the Hagan had the appearance of being heavily rusted, and a gummy residue remained on portions of the inner surface of the Hagan that were in contact with the bag. The coating was found to be wipeable and was removed from some of the surface with a wet rag.

Figure 2. Condition and packaging configuration of the XBPS333 Hagan: (A) inside of outer container, (B) inside of lid, (C) outer bagout bag, (D) inner bagout bag, (E) inner container holding the chunks of material, and (F) inside of inner container.

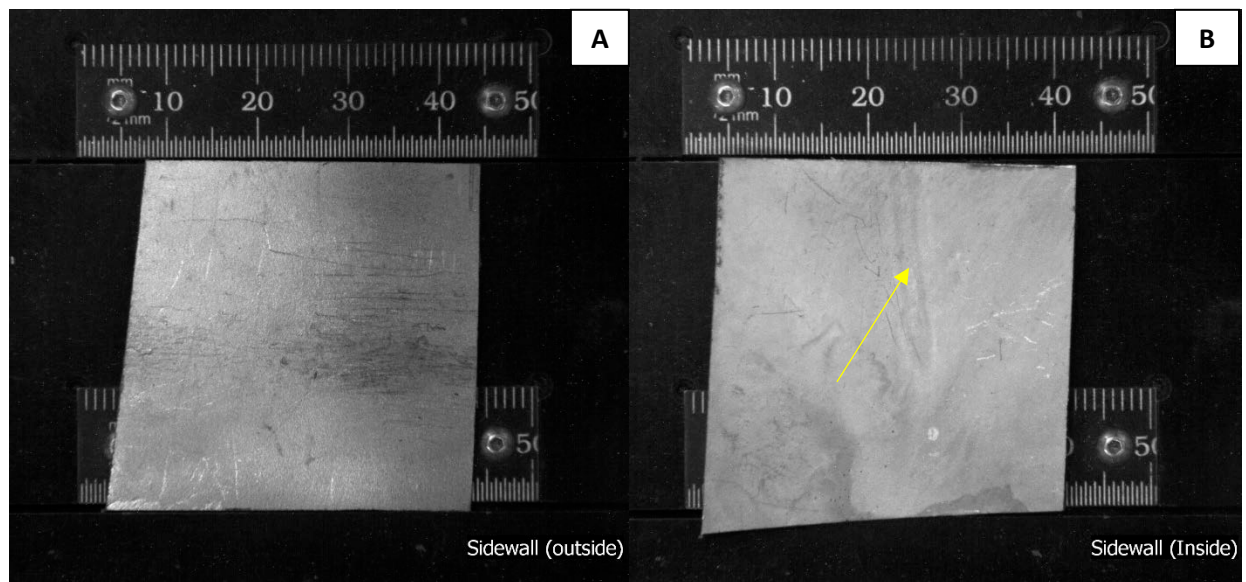
Images showing the condition of the XBPS333 Hagan specimens after cleaning are presented in Figures 5 and 6 below. The brown coating was removed from all of the XBPS333 specimens. Comparing the surfaces of the unused Hagan with the XBPS333 Hagan we found three major differences resulting from corrosion that occurred during storage. First, areas of staining or an adherent coating remained on the inside surfaces of XBPS333 Hagan (indicated by yellow arrows in Figures 5B and 6B). Second, the collar of the XBPS333 Hagan had an uneven finish with both shiny and dull areas. Third, the weld of the XBPS333 Hagan had a dull finish; whereas, the weld of the unused Hagan had a shiny finish.

Figure 5. Images showing the outside (A) and inside (B) surfaces of the XBPS333 Hagan sidewall (Specimen 1) after cleaning. The yellow arrow shows an area of staining possibly due to adherence of the bagout bag to the container wall.

Isolated areas containing corrosion pits were observed on this specimen. The highest concentration of pits was observed in the immediate area surrounding the staining as indicated by the yellow arrow in Figure 5B. The pit diameters were mostly on the order of 5 to 30 microns, but some larger pits and agglomerated pits were observed. Figure 12A shows several pits observed in this region. Pit 1 was the largest pit observed at approximately 105 microns in diameter and approximately 40 microns deep. Pits 2 and 3 are approximately 30 microns in diameter. The depth of pit 3 is approximately 30 microns. The depth of pit 2 was not estimated. Figure 12B shows the variety of pit shapes ranging from small and circular on the far left of the image to long and agglomerated in the center and right side of the image. (The light colored features indicated by arrows are below the surface.) The depths of the features in Figure 12B were on the order of 10 microns or less. Figure 12C shows a hemispherical pit (pit 4) indicated by the yellow arrow. The diameter measured 26 microns, and its depth was between 10 and 20 microns. Figure 12D shows an area densely populated with relatively small pits on the order of 20 microns in diameter.

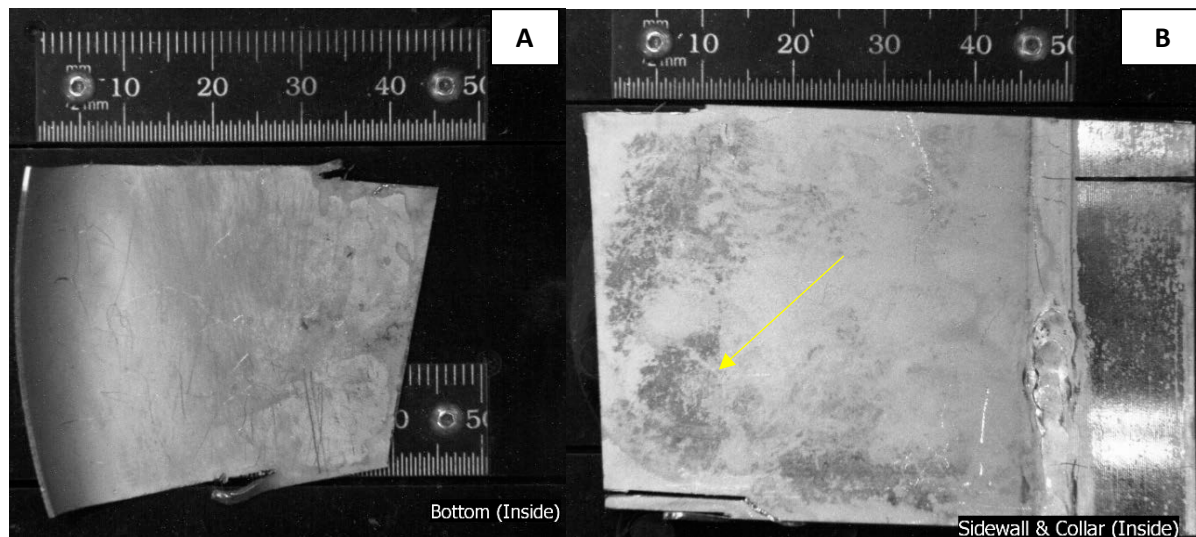
Figure 6. Images showing the inside surface of the bottom (Specimen 2) (A) and the inside surface of sidewall (Specimen 3) (B) of the XBPS333 Hagan after cleaning.

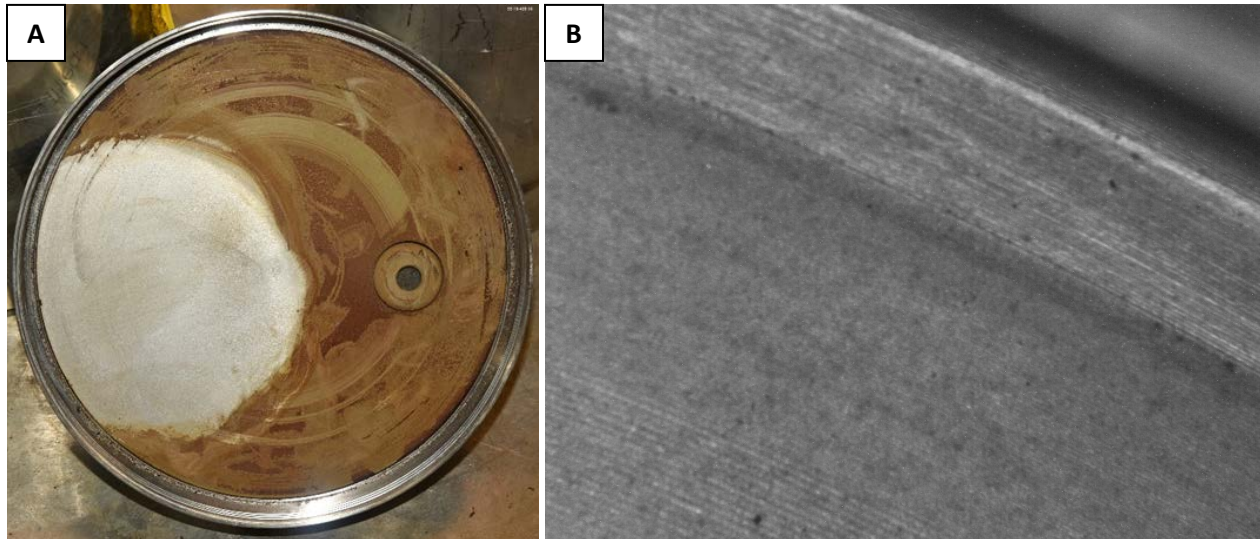
The XBPS333 Hagan lid was cleaned by wiping with DI water on a wet cloth. Images of the lid after cleaning are shown in Figure 7. The brown coating was completely removed from the lid. Under the coating, the lid had a dull finish except for areas that were protected by the O-ring seal. The difference between these areas is shown in Figure 7B.

Figure 7. Removal of the wipeable coating from a portion of the XBPS333 Hagan container lid (A) and macroscopic image showing the difference in surfaces between areas of the lid protected (shiny) by the sealing surface and those exposed to the inside of the container (dull) (B).

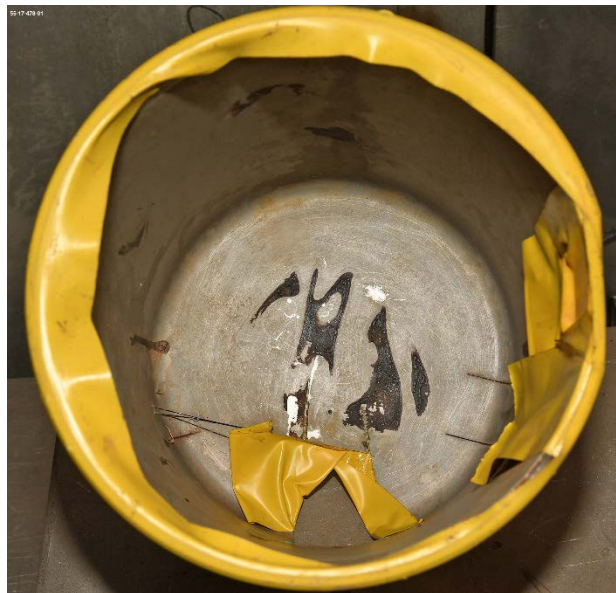
The XBPS333 Hagan body was cleaned by wiping with DI water on a wet cloth. An image of the container body after cleaning is shown in Figure 8. Portions of the degraded bagout bag remained on the surface as well as large areas of staining.

Figure 8. Inside surfaces of the XBPS333 Hagan after cleaning with a wet cloth.

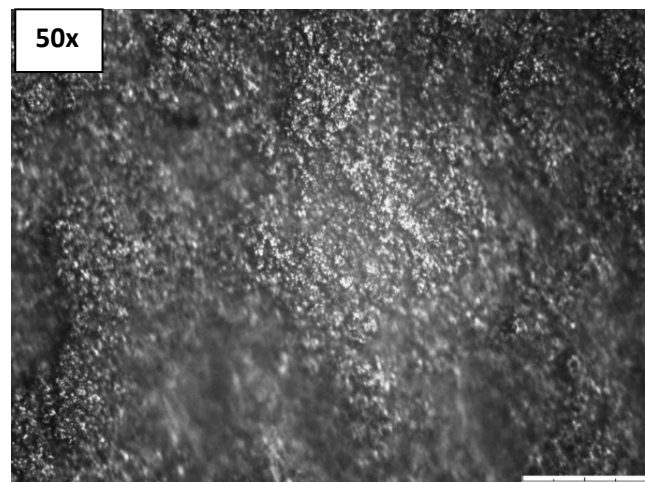
Microscopic images were taken using 50X magnification in various regions of specimen 1, taken from the bottom of the XBPS333 Hagan. Comparing sidewall surfaces of the XBPS333 Hagan and unused Hagan (Figures 11 and 10A, respectively), it is evident that the ridges and valleys that cover the surface of the unused Hagan were not present anywhere in the XBPS333 Hagan specimen. It is unclear whether the ridges and valleys were eroded by general corrosion or whether the difference is due to the fabrication process.

Figure 11. Inside surface of specimen 1 imaged at 50X magnification. (The length of the scale bar at the bottom-right represents 50 microns).

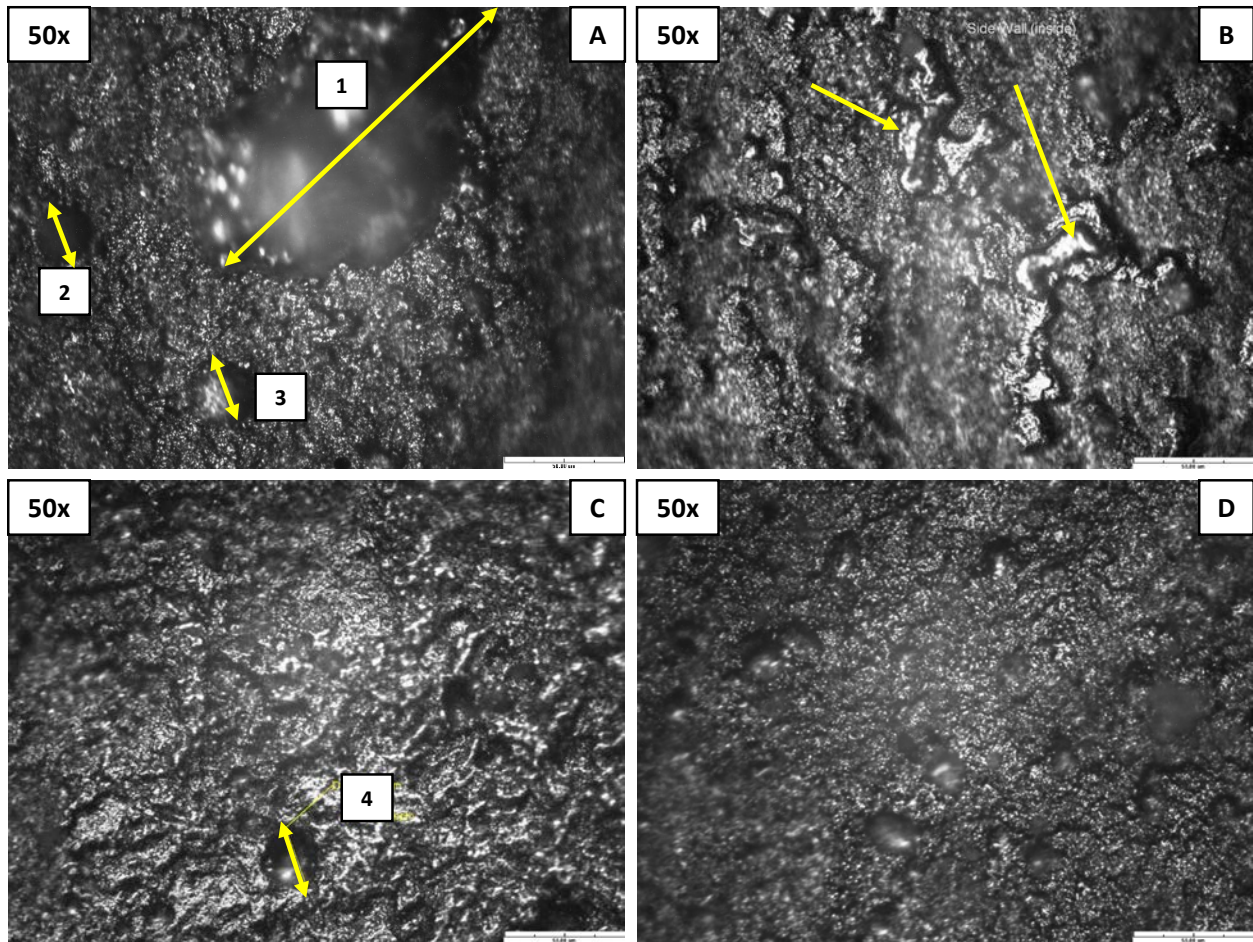
Figure 12. Areas of the specimen 1 containing corrosion pits imaged at 50X magnification. (The length of the scale bar at the bottom-right of each image represents 50 microns).

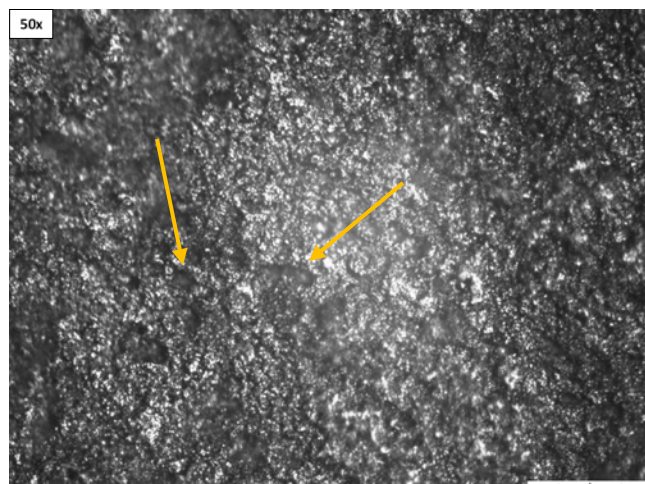
The inside surface of specimen 2 taken from the bottom of the XBPS333 Hagan was scanned for features using 50X magnification. A microscopic image representing this region was obtained and is shown in Figure 13 and shows that the bottom of the container has a similar appearance to that of the sidewall specimen (Figure 12). The ridges and valleys observed in the unused Hagan specimen are absent from this specimen. Some areas were found to have small, round, shallow features, which have the appearance of shallow pits. These features, on the order of 10 to 20 microns in diameter, were the largest features observed in this specimen.

Figure 13. Inside surface of specimen 2 imaged at 50X magnification. Yellow arrows indicate round features resembling shallow pits. (The length of the scale bar at the bottom-right represents 50 microns).

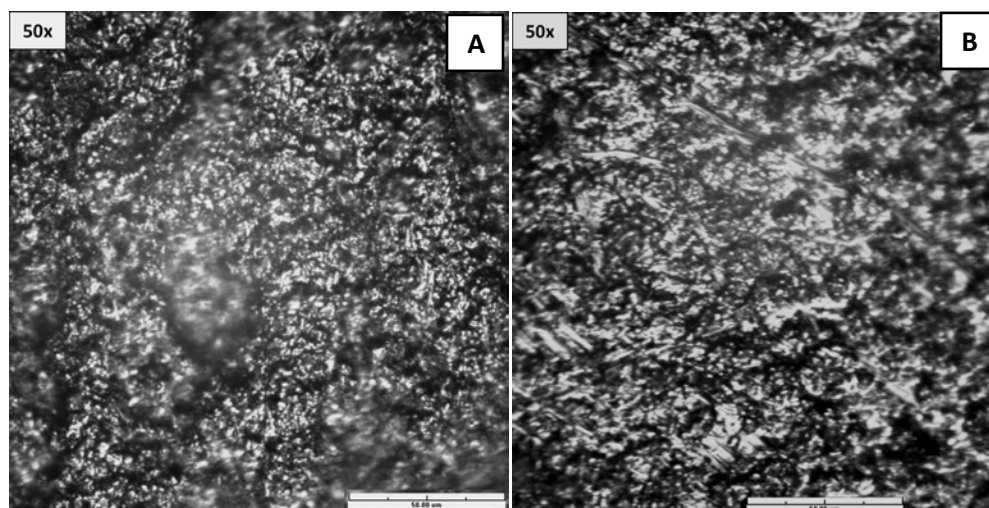
The inside surface of the specimen 3 taken from the top of the XBPS333 Hagan was scanned for features using 50X magnification. The surfaces of the sidewall below the weld (Figure 14A) have similar appearance to the container specimens 1 and 2 from the bottom and sidewall. No pits or cracks were observed in the sidewall or weld regions. The ridges and valleys observed in the unused Hagan specimen were not observed in this specimen. The weld region in the XBPS333 Hagan (Figure 14B) had a similar appearance to sidewall surfaces elsewhere in the XBPS333 container rather than the weld surface in the unused Hagan (Figure 10B). It is unclear whether the difference in the surfaces between the unused Hagan and the XBPS333 Hagan are the result of corrosion or differences in the fabrication process.

Figure 14. Inside surfaces of specimen 3 imaged at 50X magnification. (A) Inside sidewall below weld, (B) Inside sidewall at the middle of the weld. (The length of the scale bar at the bottom-right of each image represents 50 microns).

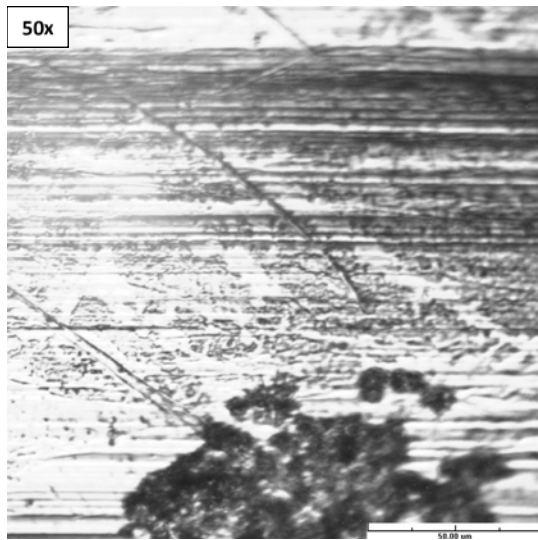
The collar of the XBPS333 Hagan was also scanned for features using 50X magnification. The machining marks in this region are punctuated by features that are possibly areas of small, agglomerated pits or

general corrosion. Those features, which appear as dark areas at the bottom center of Figure 15 were not observed on the unused Hagan.

Figure 15. Inside surfaces of specimen 3 at the collar of the XBPS333 Hagan imaged at 50X magnification. (The length of the scale bar at the bottom-right represents 50 microns).

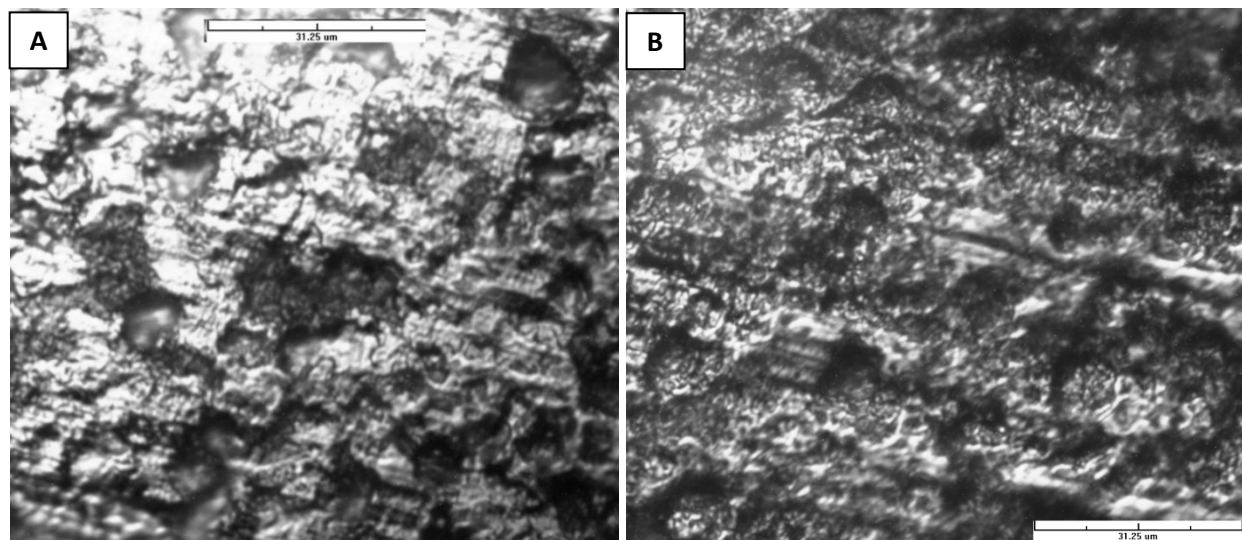
Microscopic images of the cleaned, inside surface of the XBPS333 Hagan lid were obtained at 80X magnification. The microscopic image is shown in Figure 16. Light colored regions indicate areas of clean metal bearing its machining marks, which are punctuated by dark irregular-shaped circular-shaped features resembling corrosion pits. The size of the circular pits ranged from approximately 5 to 15 microns in diameter. All of the features were shallow (less than 10 microns).

Figure 16. Inside surface of the XBPS333 Hagan lid imaged at 80X magnification. (The length of the scale bar at the bottom-right represents 31.25 microns).
